# Background & Historical Issues

Coastal Protection Report: River Hamble to Salterns Park

**EASTERN SOLENT | COASTAL PARTNERSHIP**

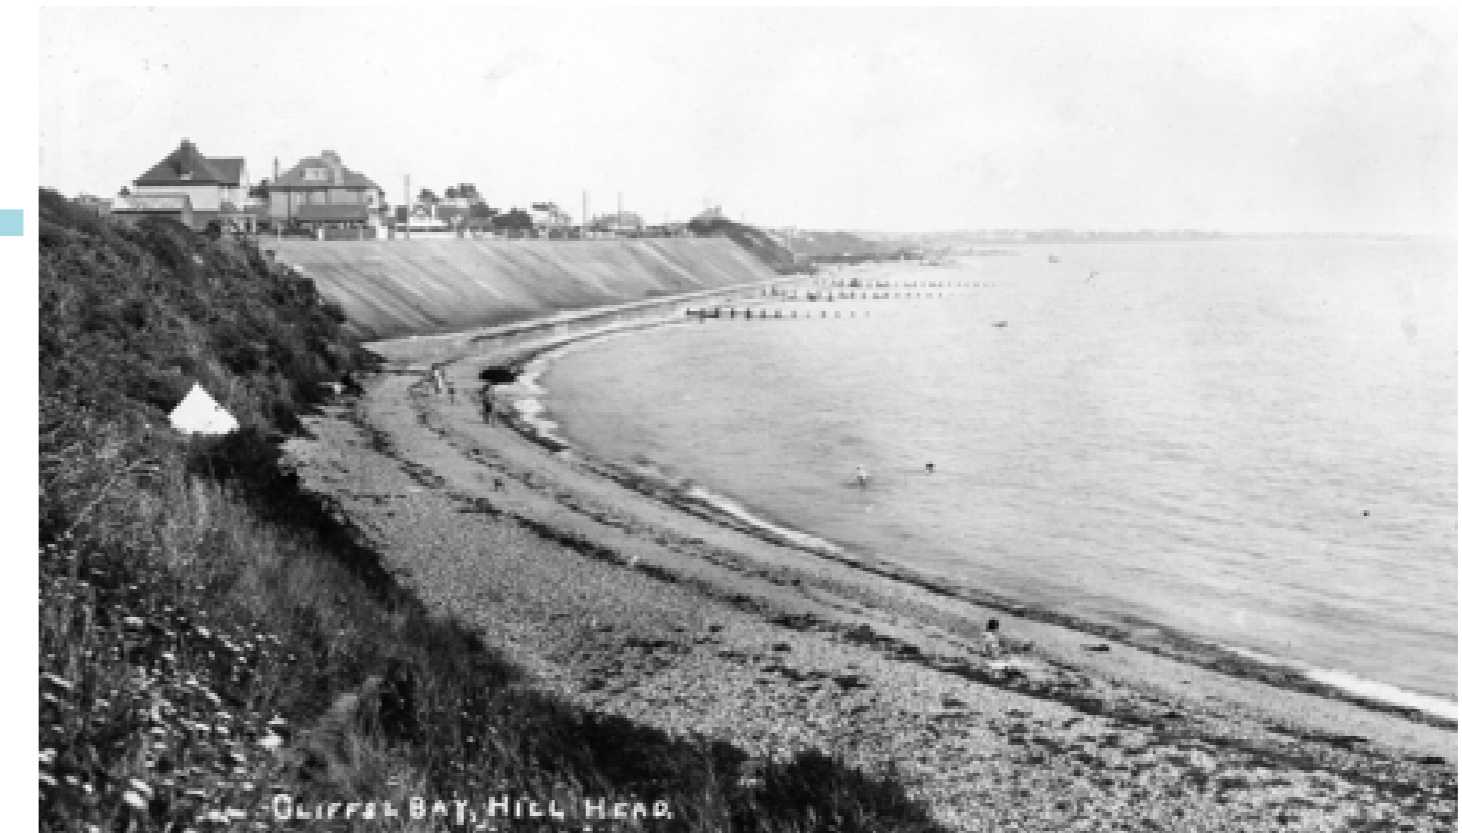
Groyne construction. Local cliff collapse visible

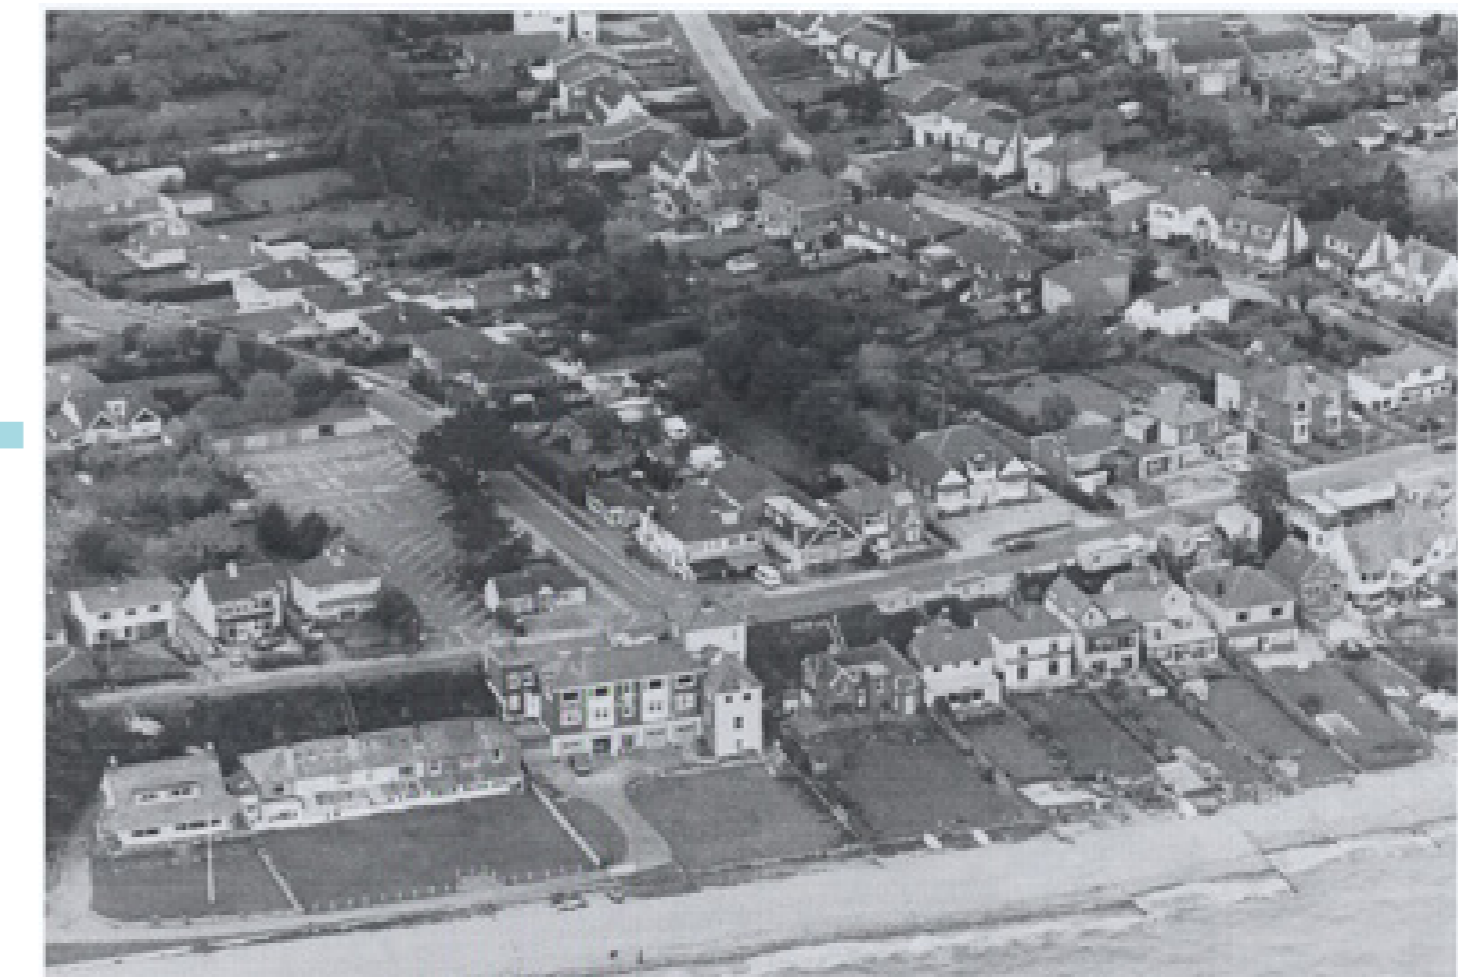
2005

Seawall failure at the 'kink' and repair

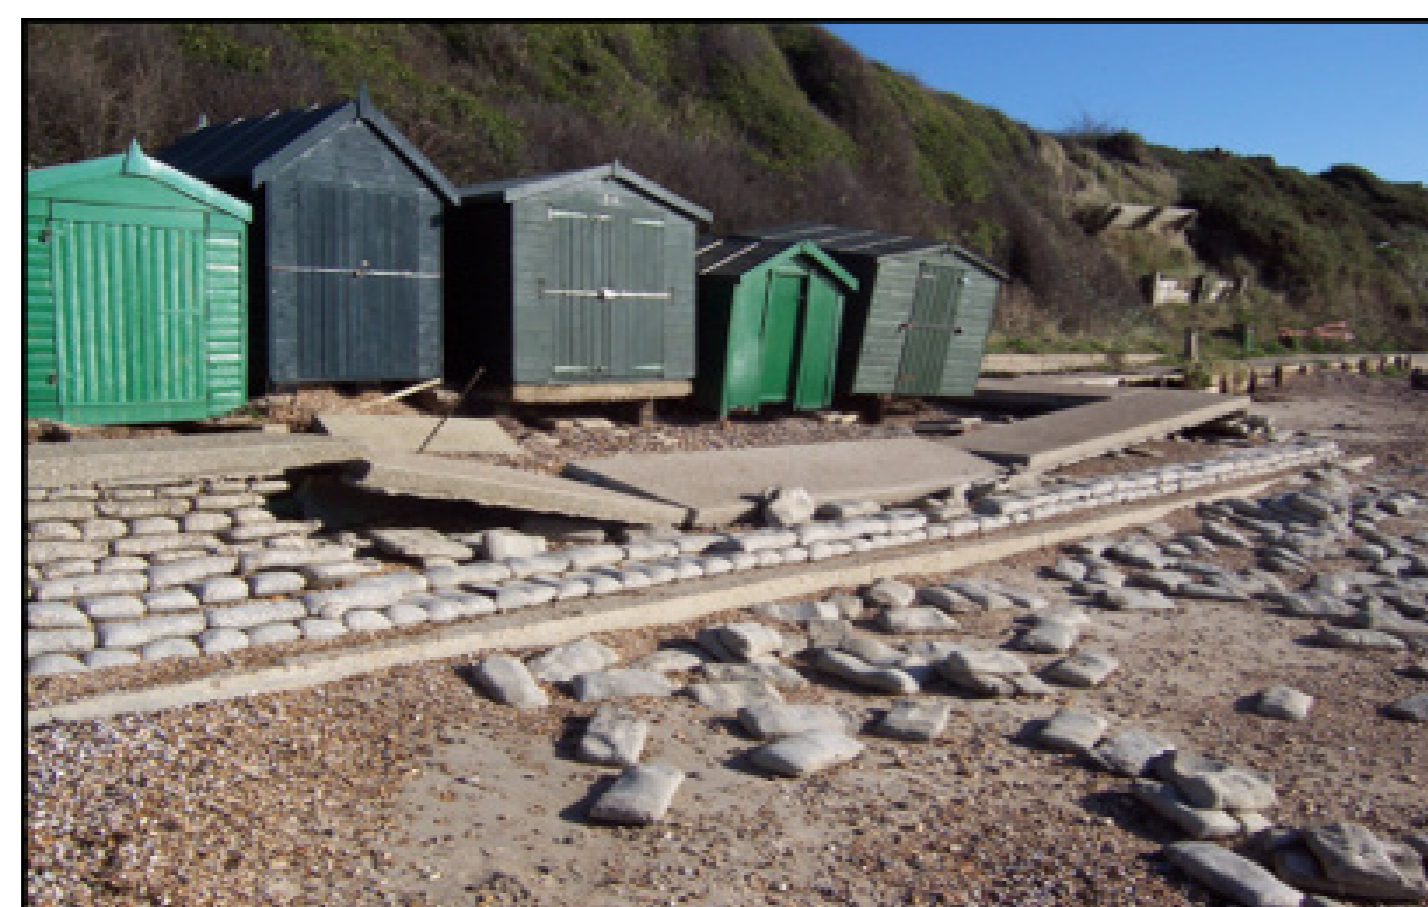
2012

Beach levels close to prom height

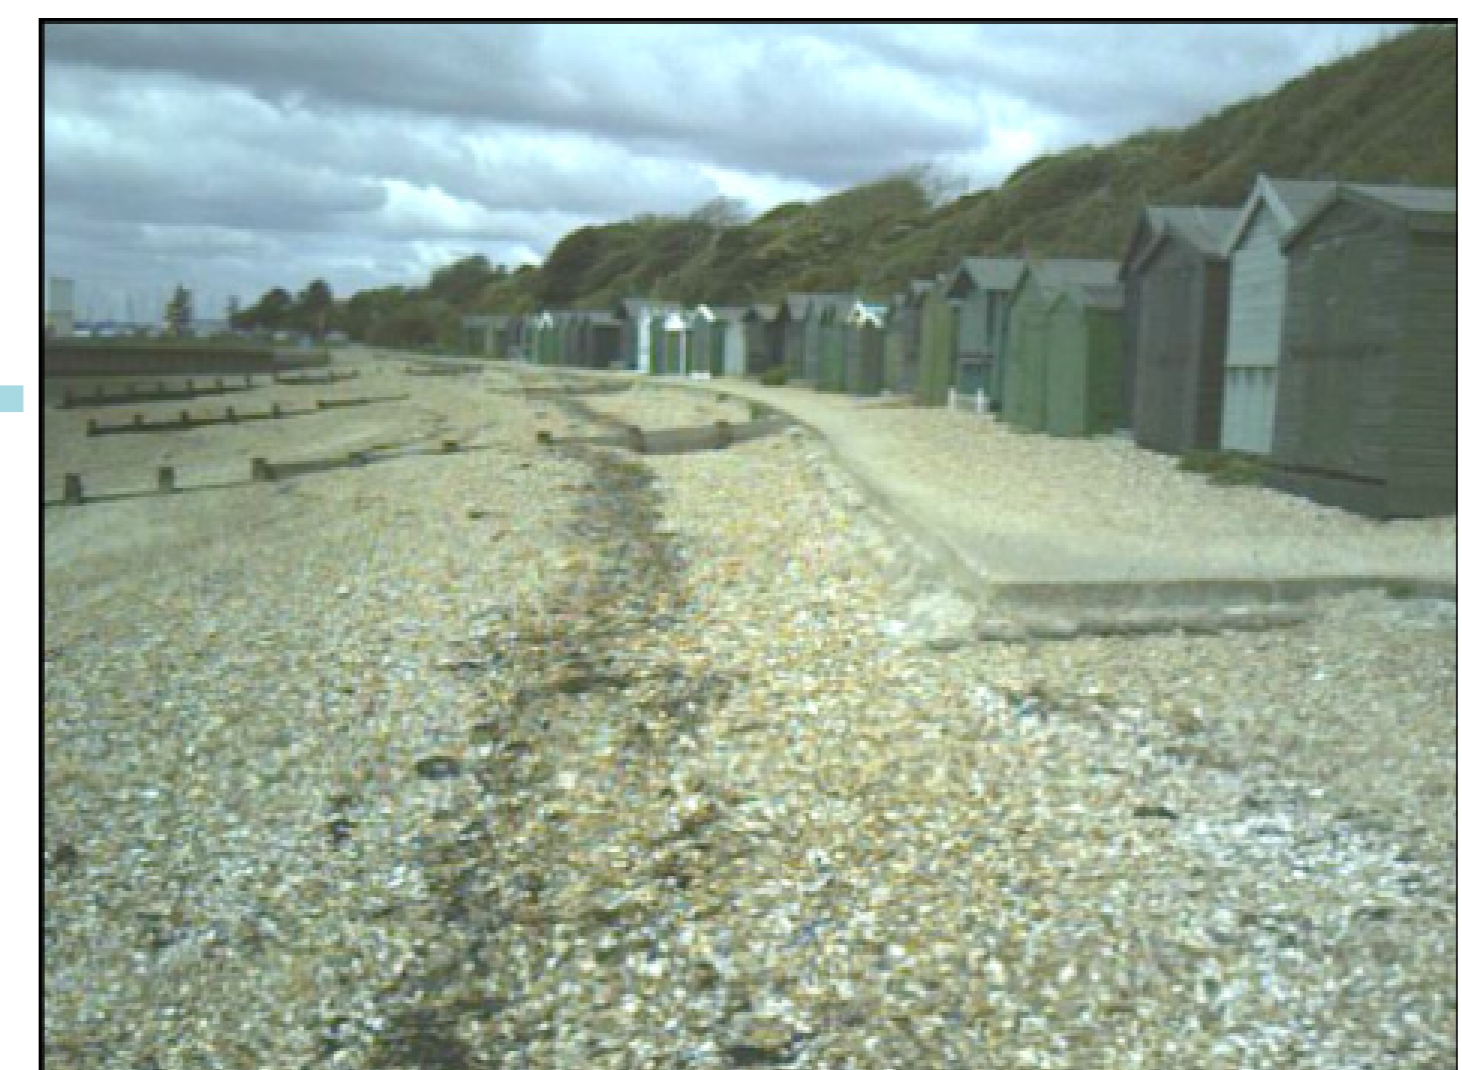
2014

2014: Gabion Basket Repairs following winter 2013/14 storms

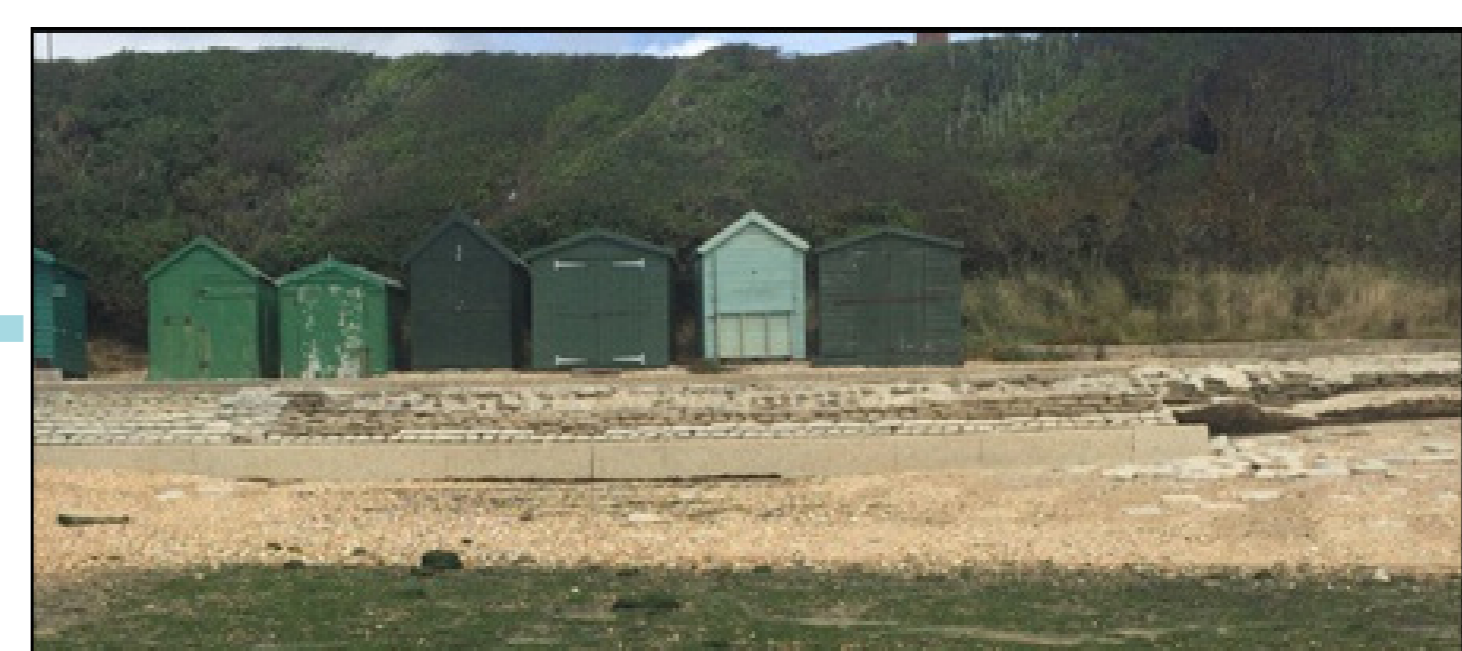
2016

Prom open but failed seawall remains

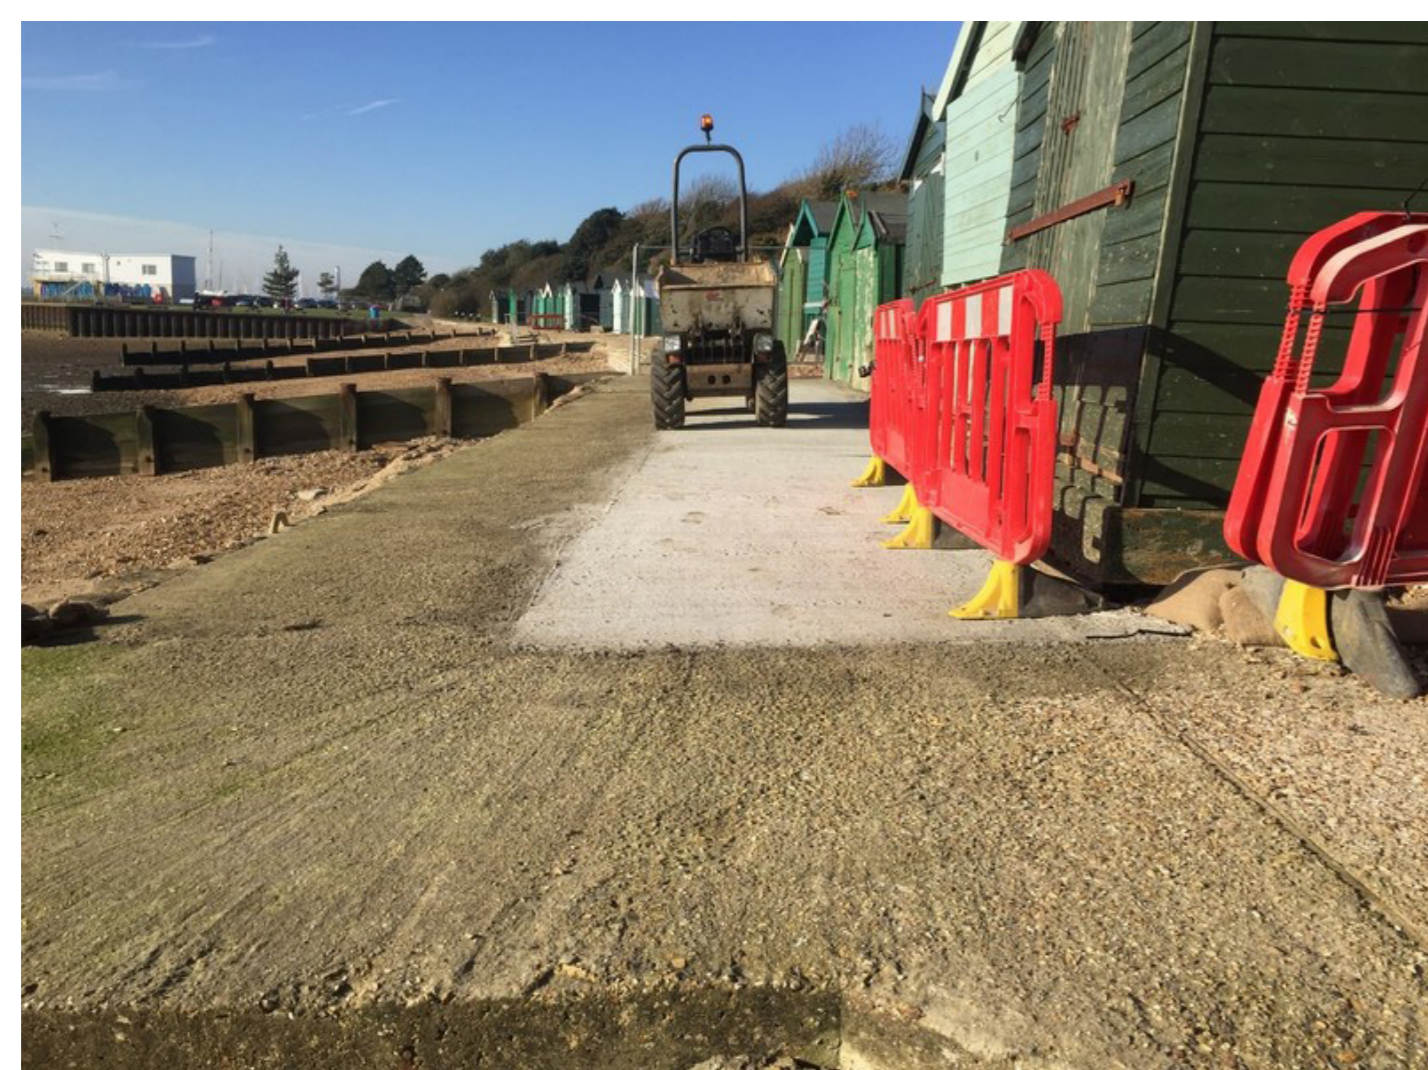
August: Beach levels fall damaging seawall foundations

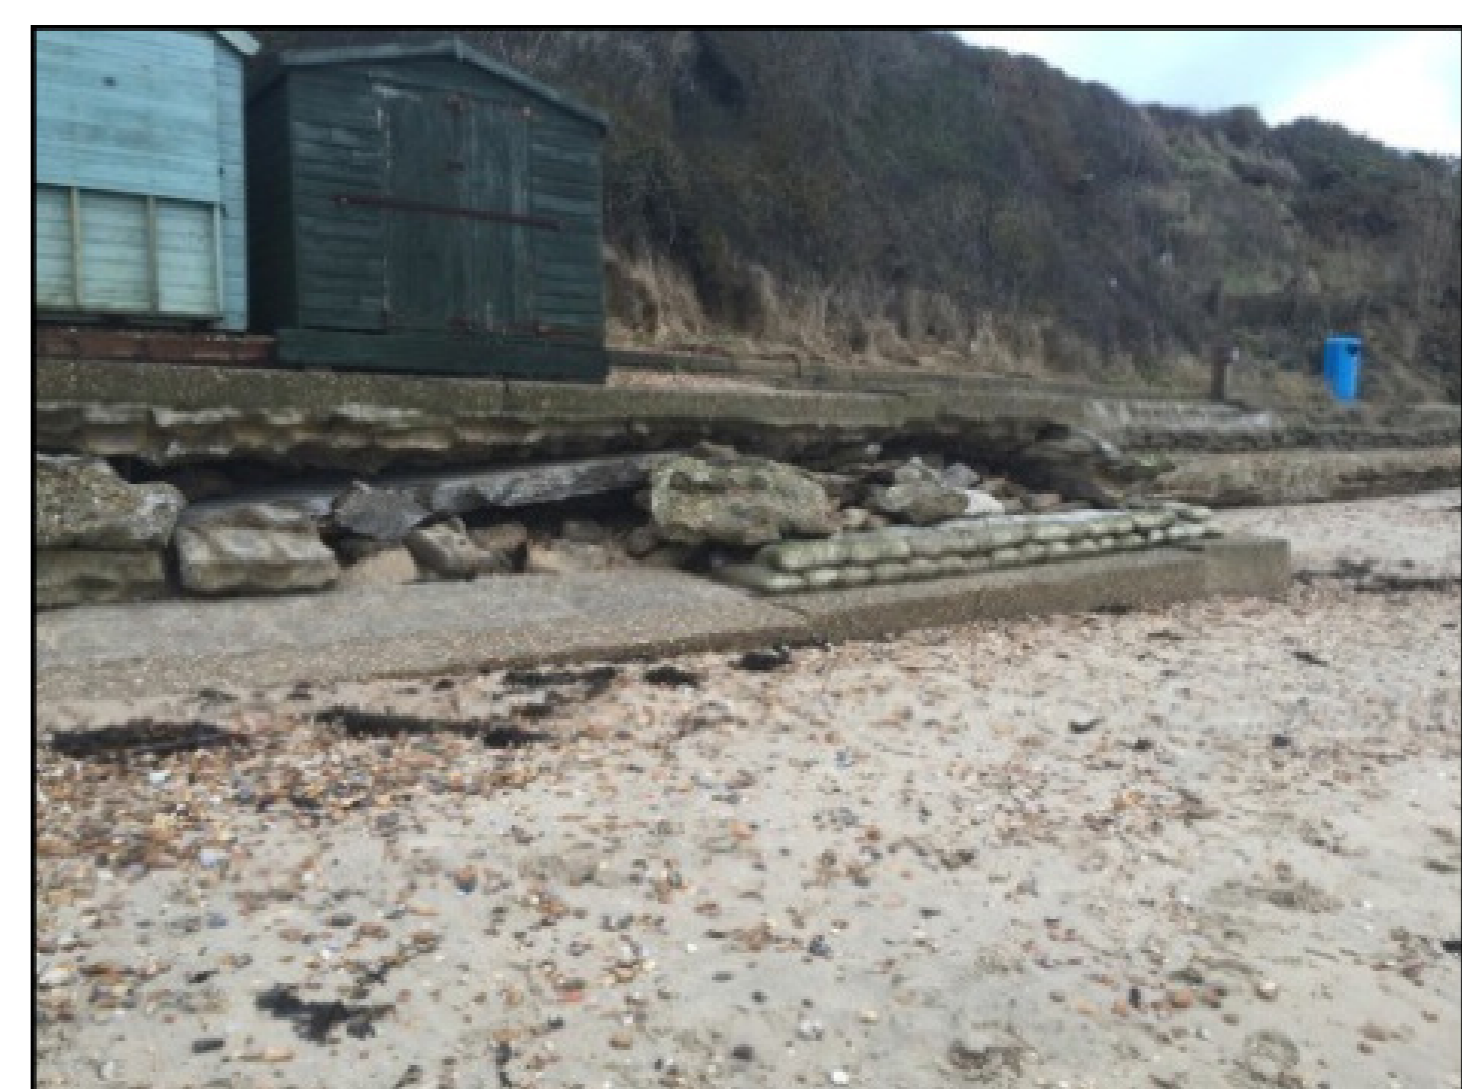
December: Prom closure and seawall failure
